**CALSPAN ON-SITE INVESTIGATION OF TWO COMPRESSED NATURAL GAS
(CNG) CYLINDER RUPTURES
CALSPAN CASE NOS. 94-19 AND 94-20**

VEHICLES - TWO 1992 GMC SIERRA 2500 PICKUP TRUCKS

**CALSPAN CASE NO. 94-19 AND CASE NO. 94-20
COMPRESSED NATURAL GAS CYLINDER FAILURES
1992 GMC SIERRA 2500 SERIES PICKUP TRUCKS**

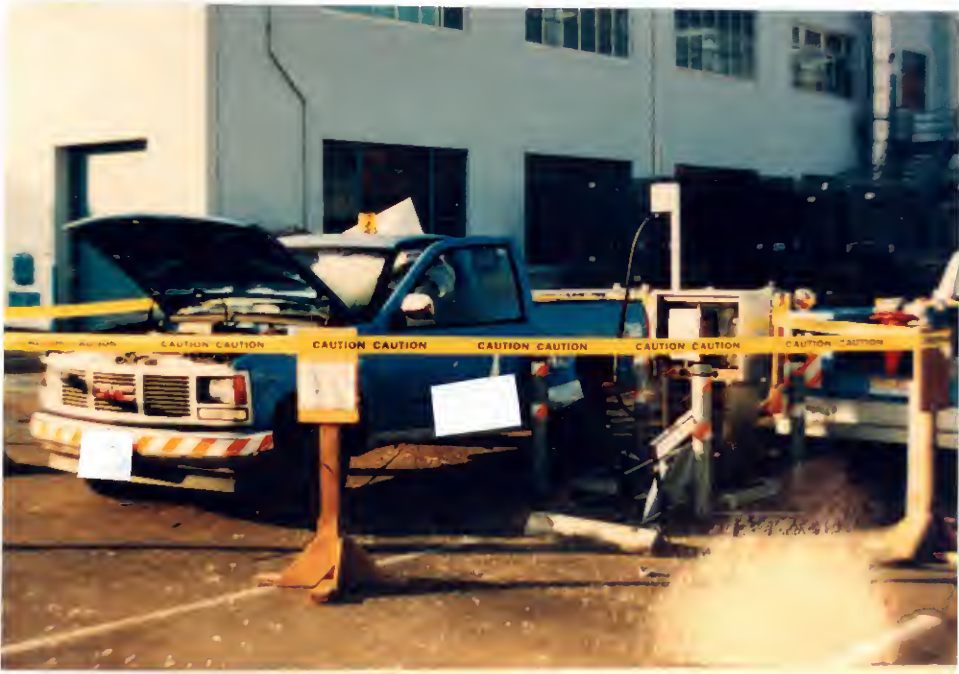
1. Damaged Vehicle and Fuel Pump at the Scene of the Incident

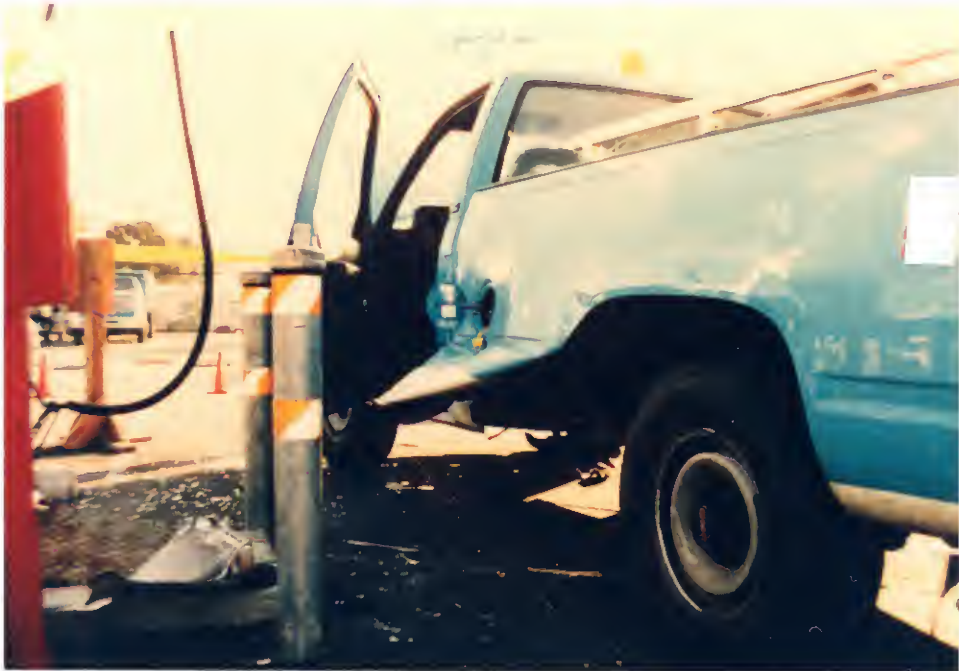
2. Left Side Damage to the CNG Truck Body and Debris

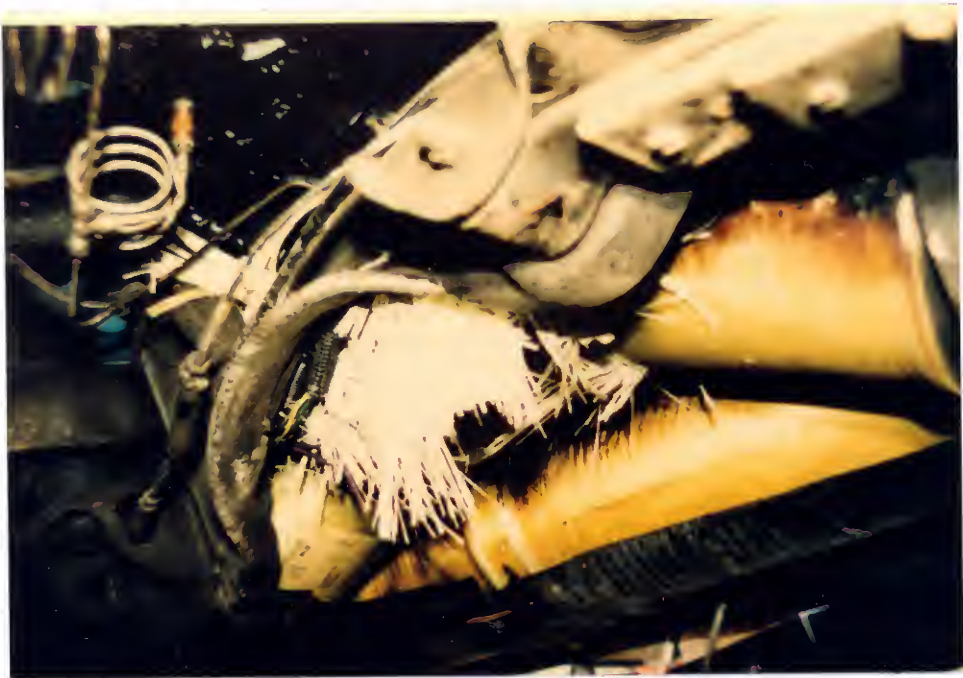
4. Undercarriage View of the Damaged Left Frame Rail at the Scene

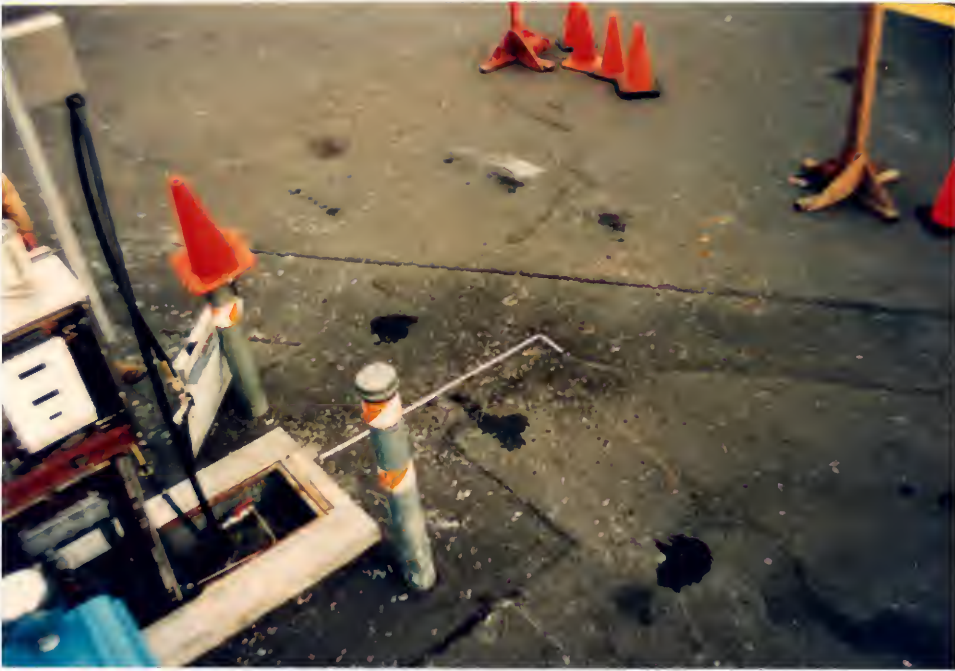
5. Damaged CNG Fuel Pump and Scattered Debris

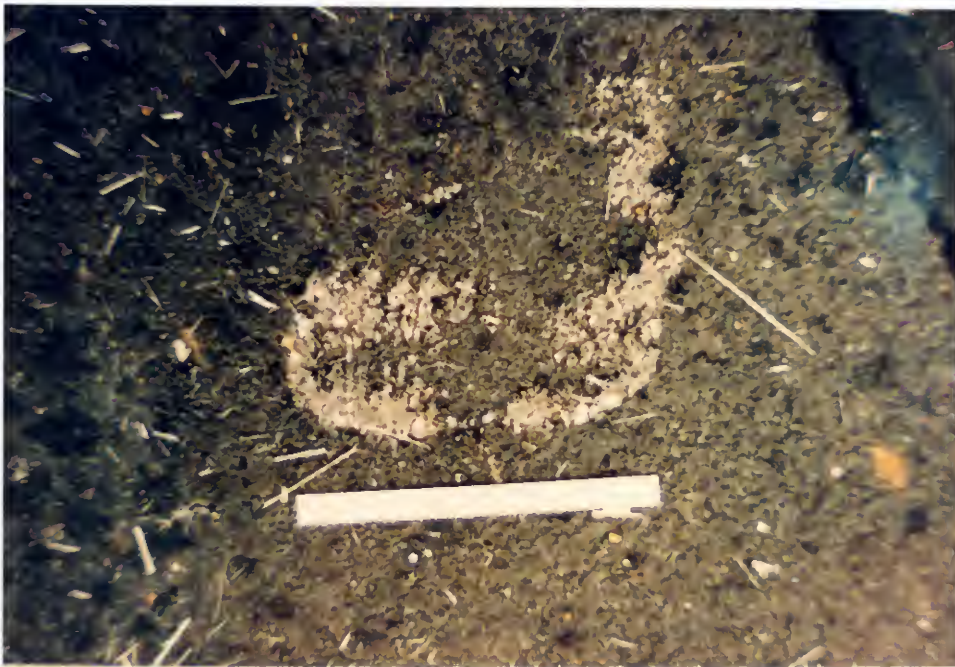
6. Cylinder Liner Fragment Impact with Asphalt Surface

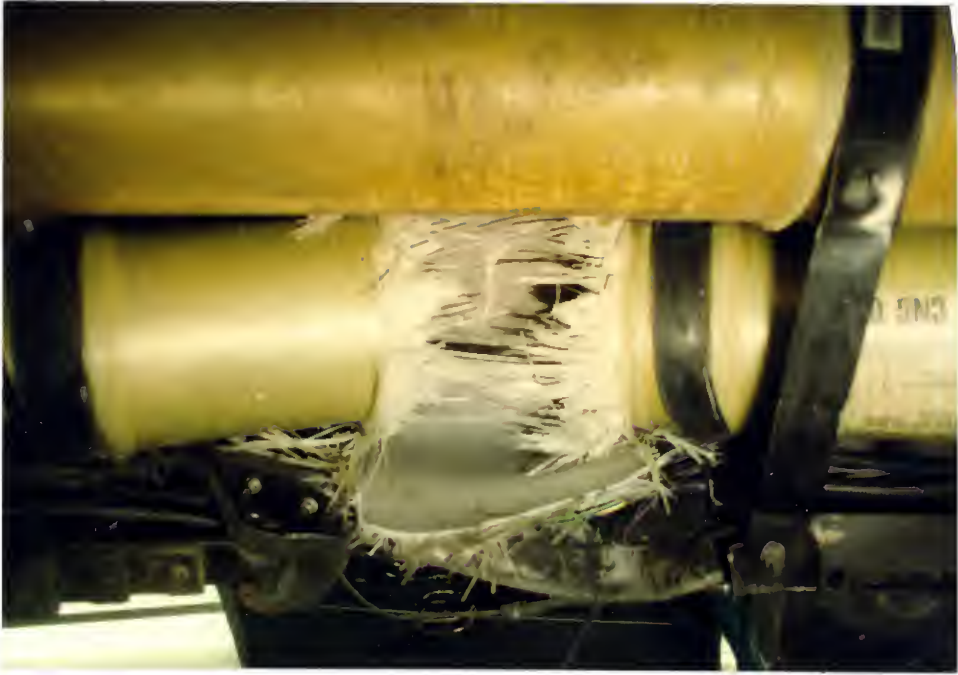
11. Undercarriage View of the Ruptured Cylinder and Resultant Damage to the Left Frame Rail and Inboard Cylinder HDPE Shield

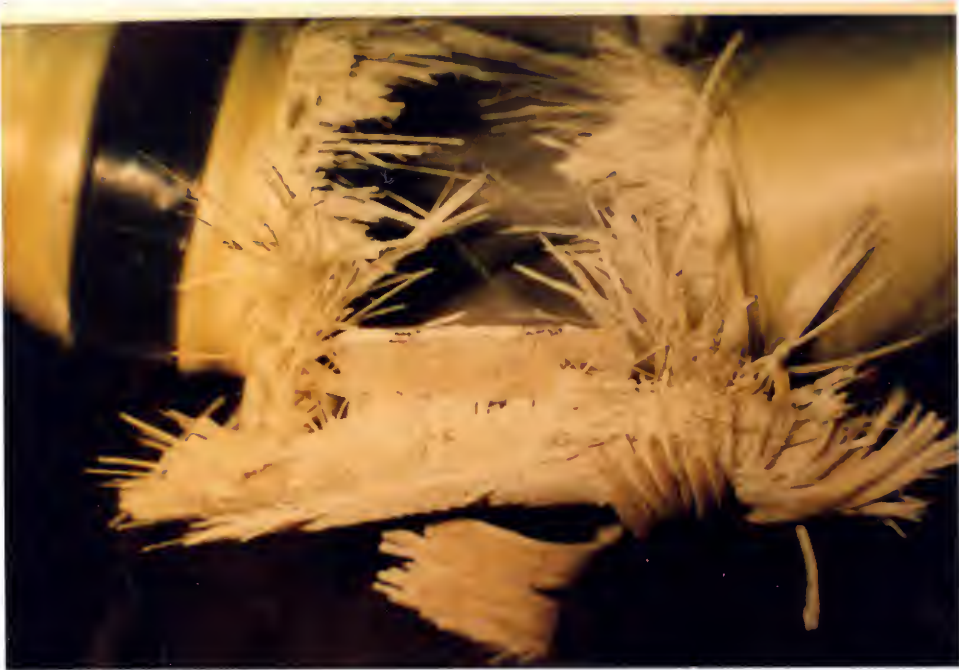
The bottom left area of the left side composite cylinder ruptured between the mounting straps at the mid point of the cylinder. The aluminum liner fractured in a longitudinal direction in an H-configuration with the flaps opening toward the sides of the vehicle. The dual direction fiberglass wrap fractured at the rupture point and partially separated from the cylinder circumferentially. The left outboard flap of the aluminum liner and the fiberglass wrap contacted the lower edge of the left C-channel frame rail between the cross-members. The contact deformed the lower edge of the rail against the inboard vertical surface of the rail and displaced the rail approximately 6.4 cm (2.5") outward. The fiberglass wrap at the inboard edge of the ruptured cylinder contacted the center cylinder's HDPE shield. The contact deformed the shield and produced laterally orientated abrasions that extended from the midpoint to the left edge of the

12. Closeup View of the Rupture Location

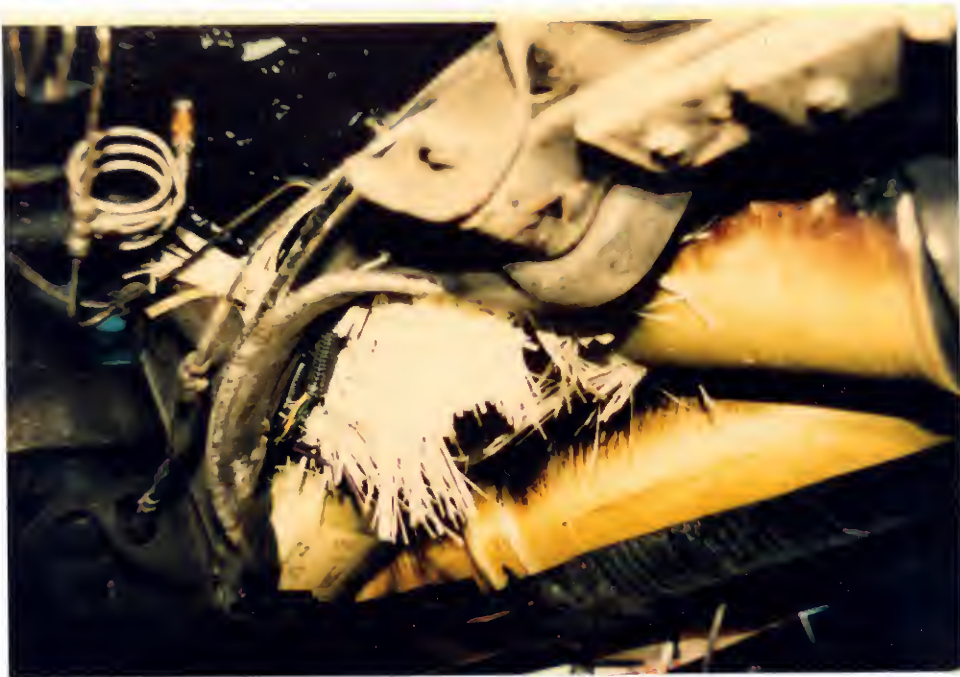
13. Closeup Views of the Resultant Frame Deformation

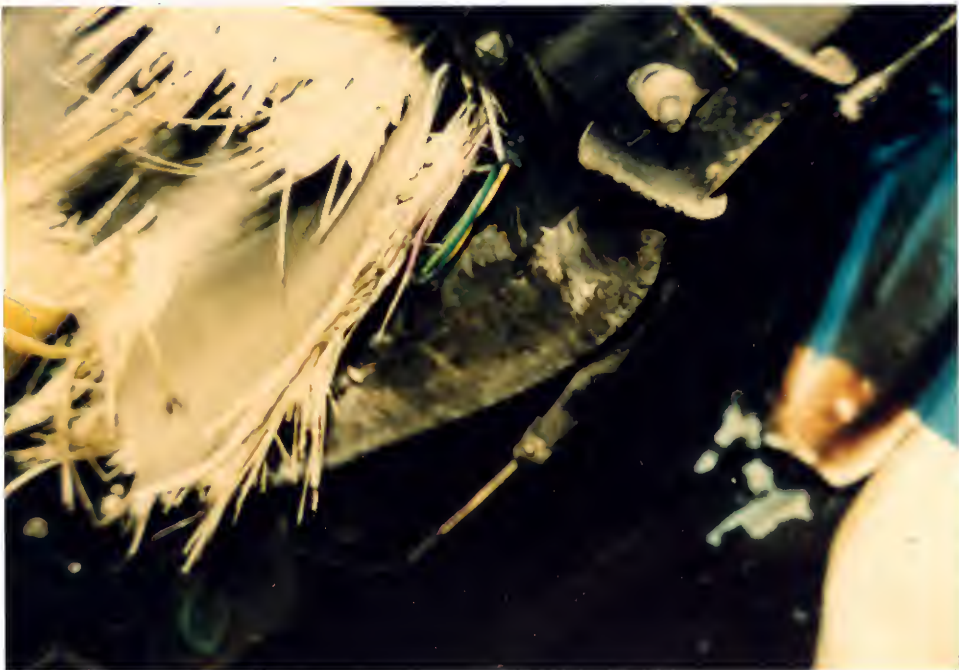
16. Closeup View of the Cylinder Flap and Frame Rail Deformation

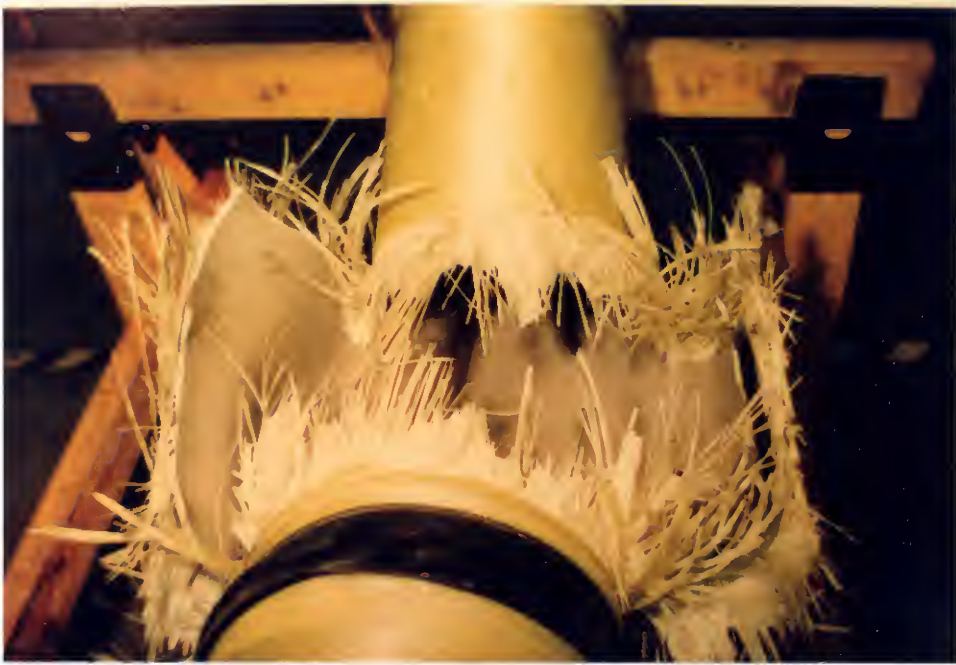
21. Longitudinal View of the H-Configuration Rupture Location

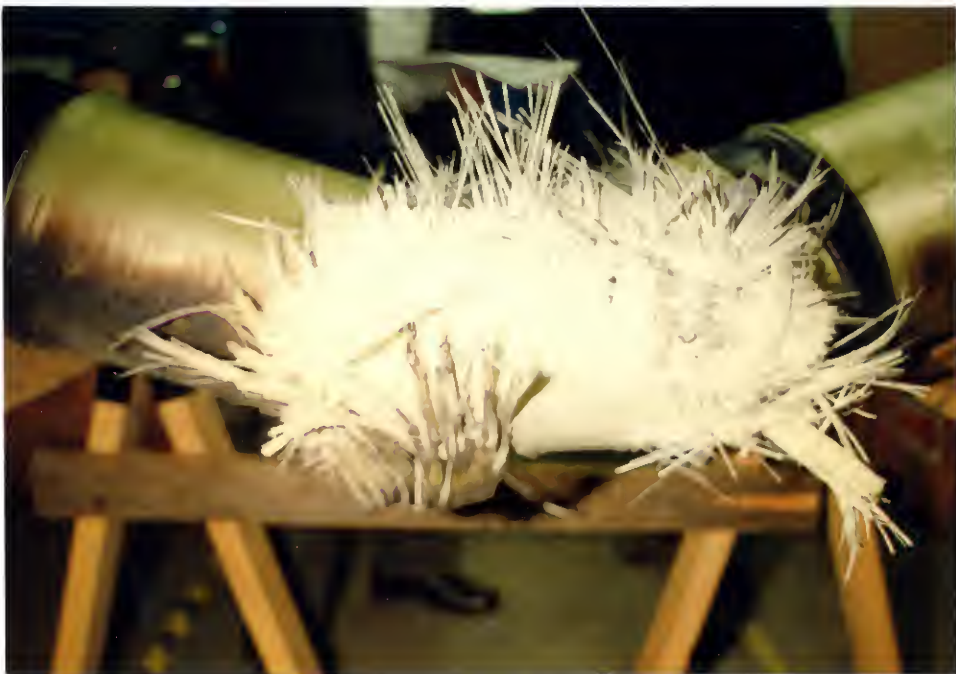
22. Outboard Side of the Separated Fiberglass Wrap

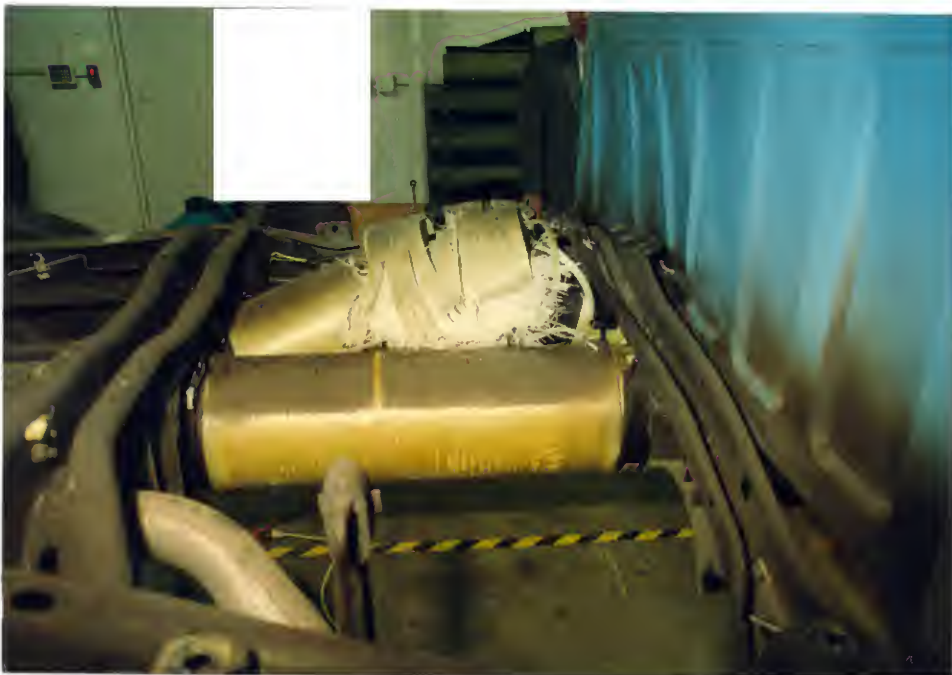
24. Inboard Side of the Separated Fiberglass Wrap

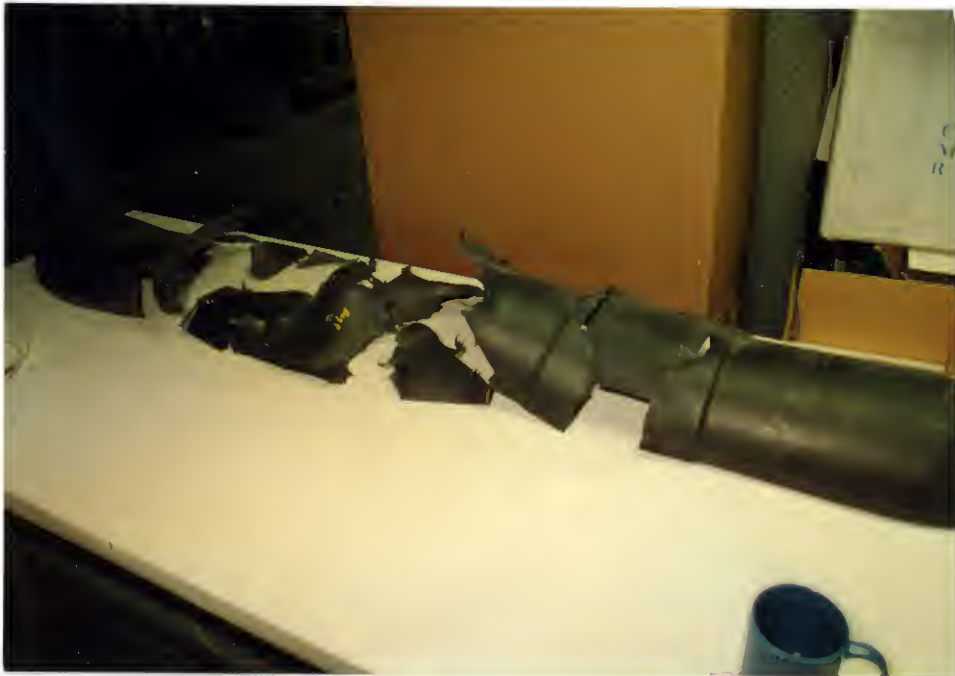
The rupture shattered the left cylinder's HDPE shield into nine separate pieces and completely separated the shield from the cylinder. The high pressure rupture of the left cylinder thrust the center area of the pressure vessel in an upward direction, thus displacing the ends of the cylinder downward. In addition, the cylinder probably rotated slightly in a clockwise direction (as viewed longitudinally from the front of the vehicle). The upward deflection of the midpoint of the cylinder stressed the common lower retaining straps for the left side cylinders. The center of the straps were cinched upward by a bolt/nut configuration which firmly secured the cylinders against the upper brackets. As a result, the tension nut pulled through the lower straps and released the tension on the straps. The fiberglass wrap and the top surface of the deformed cylinder contacted the underside of the cargo bed, which deformed the floor and unitized cross members of the bed. The thrust generated from the cylinder rupture and the debris from the fiberglass wrap deformed the lower forward edge of the left quarter panel in an outward direction. The area of deformation extended from the wheel opening to the leading edge of the bed. representatives stated that the rupture also displaced the aftermarket tool box from the bed of the truck. The tool box separated from its attachment points and came to rest upside down across the cargo bed.

25. Shattered HDPE Shield from the Ruptured Cylinder

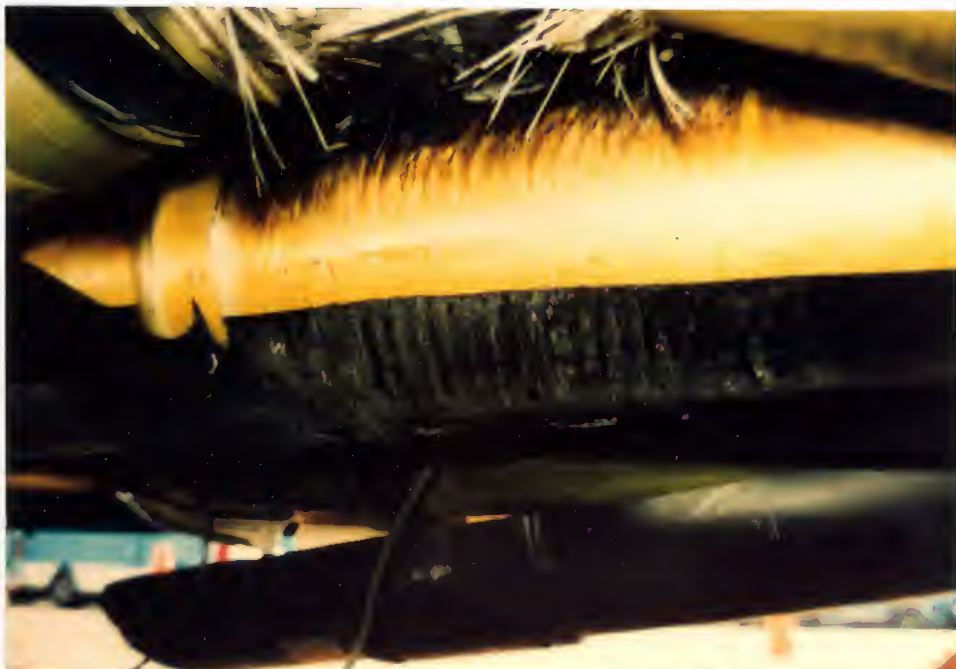
26. Contact Damage to the Center Cylinder and HDPE Shield

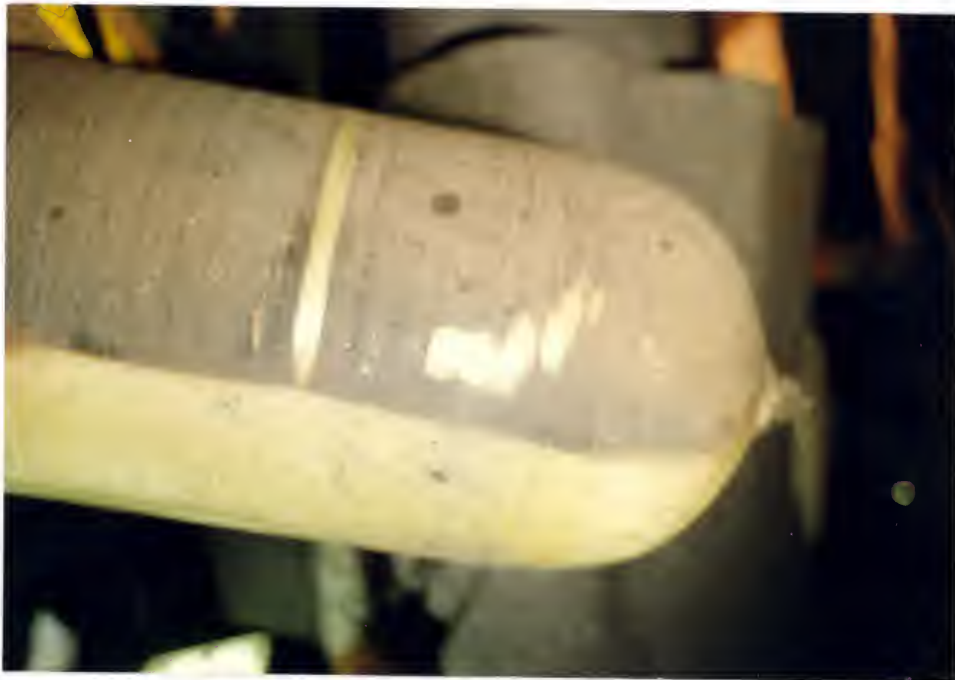
28. Brake Cable Rub Mark on the Rear of the Ruptured Cylinder

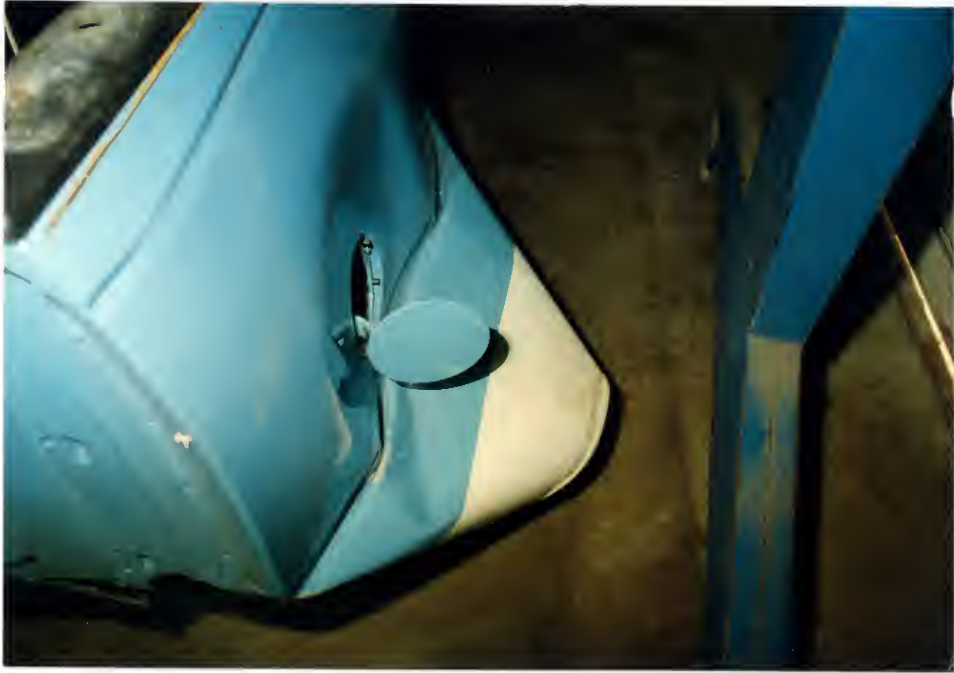
31. Outboard Deflection of the Left Lower Quarter Panel Adjacent to the Rupture Location

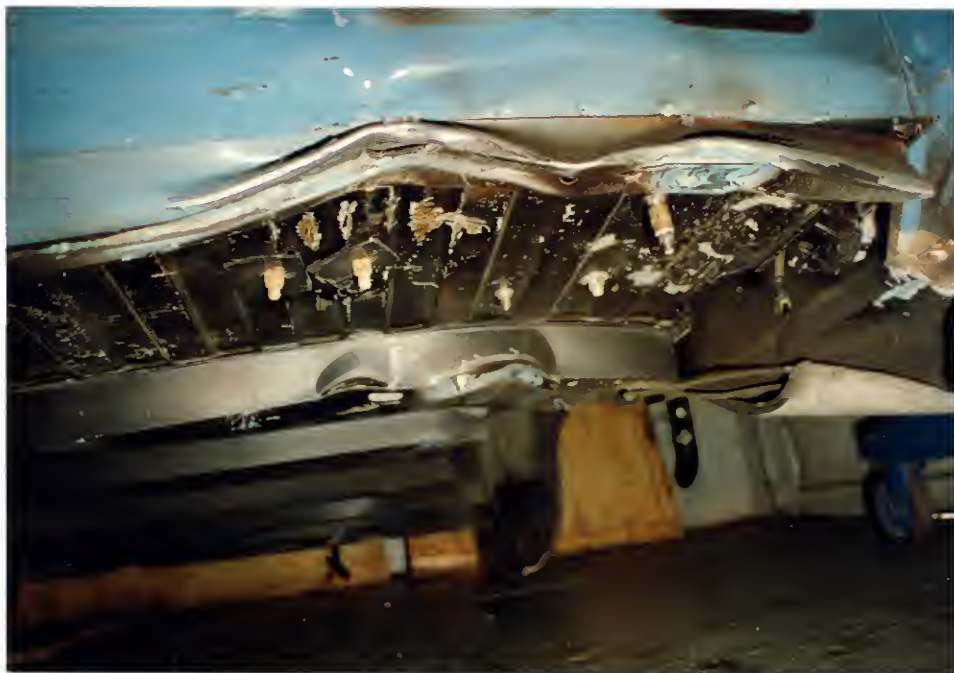
32. Damage to the Floor and Crossmembers of the Cargo Box of the Pickup Truck

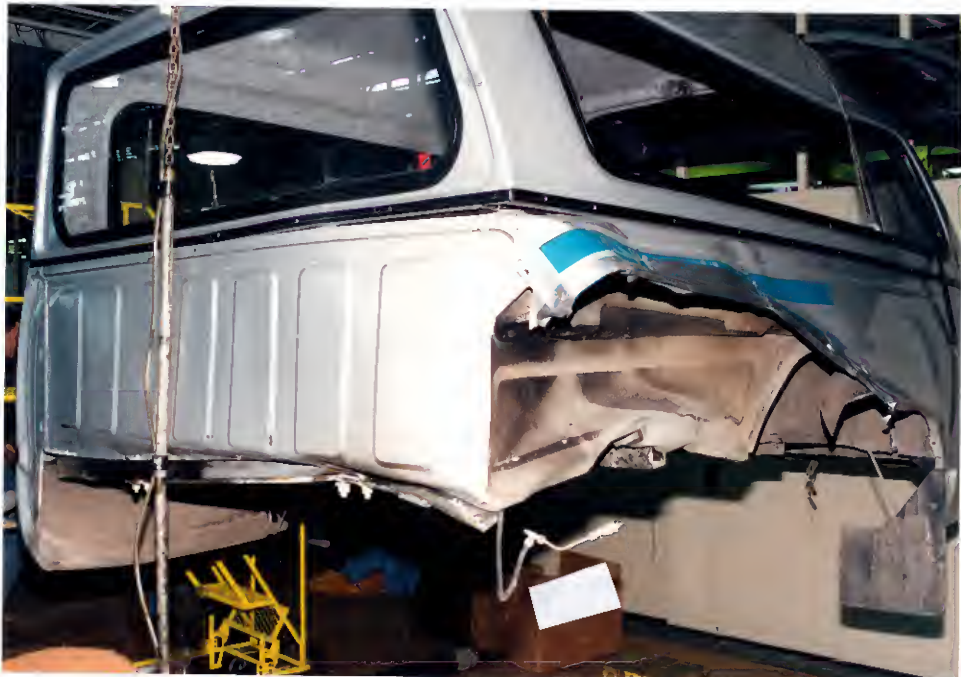
6. Left side of the cargo bed showing the damaged side panel resulting from the CNG tank failure and post event alteration

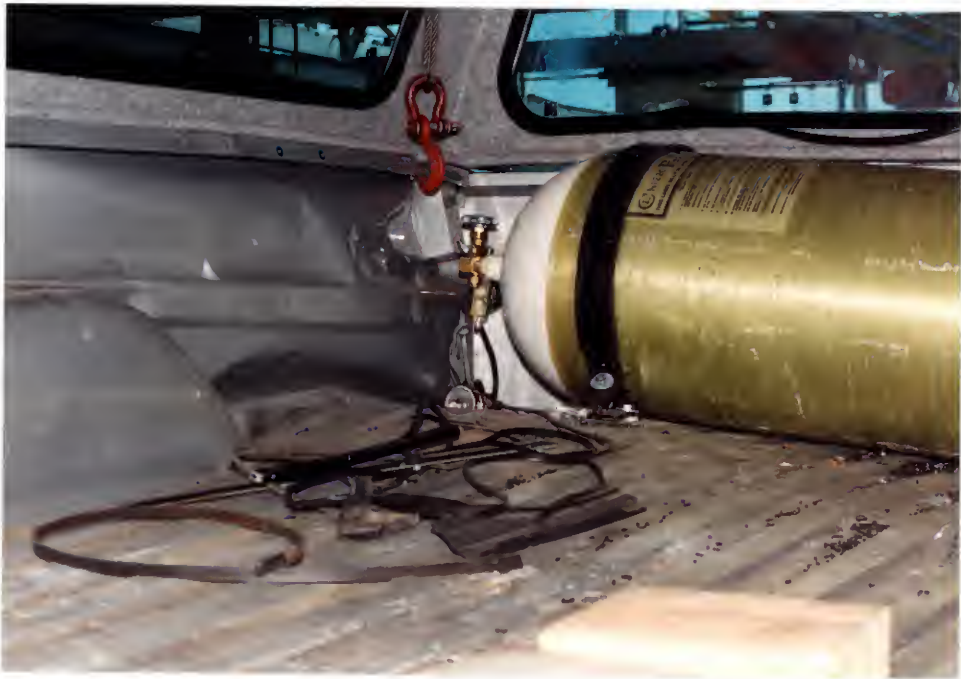
13. Angular view of the add-on tank from the right side showing deformation resulting from the CNG tank failure

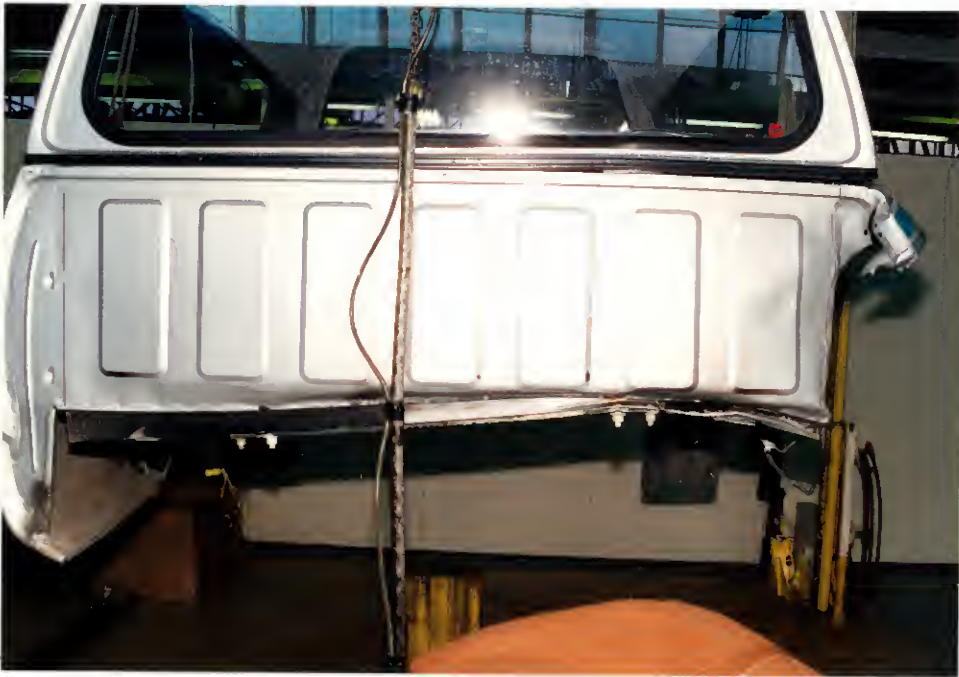
15. Frontal view of the cargo box and cap showing upward deformation along the left side from the CNG tank failure

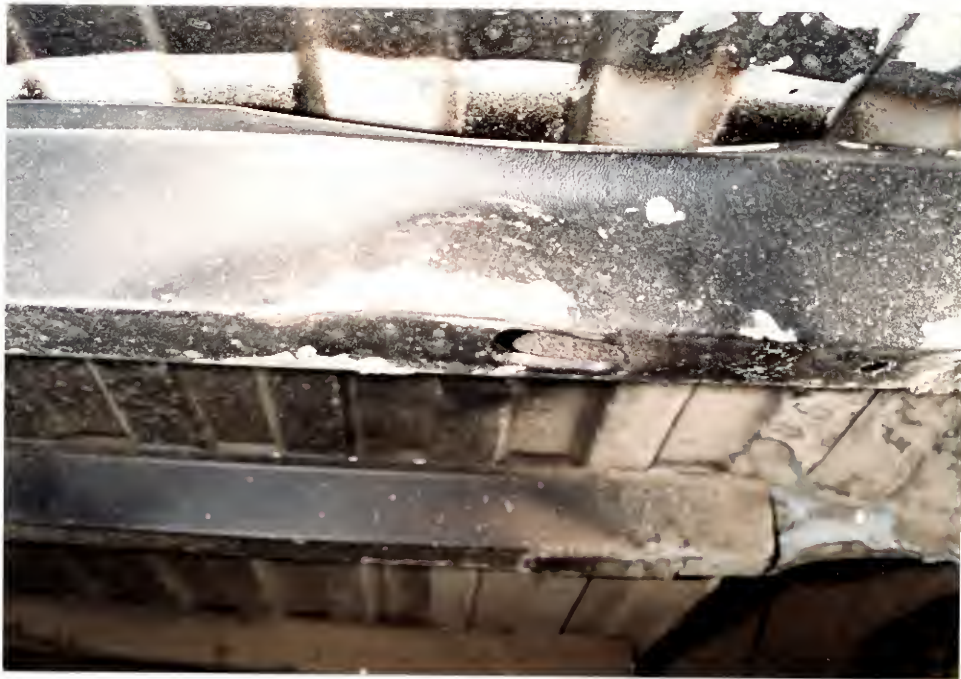
18. Close-up view of the cargo bed transverse strut showing the indentation from contact by the failed CNG tank

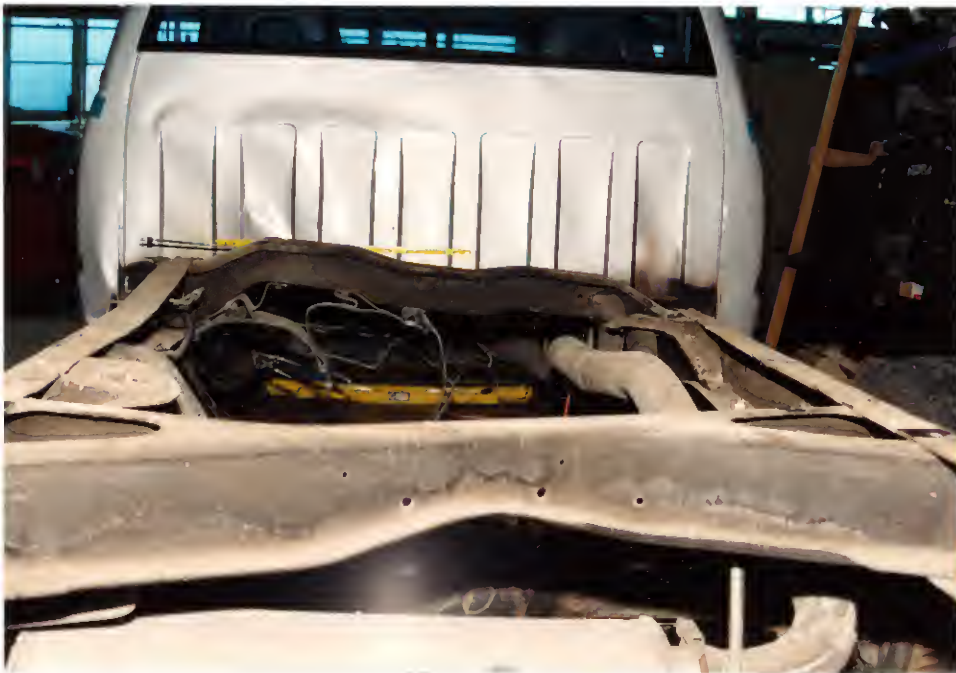
22. View of both frame rails and frame cross members illustrating the upward displacement from the CNG tank failure

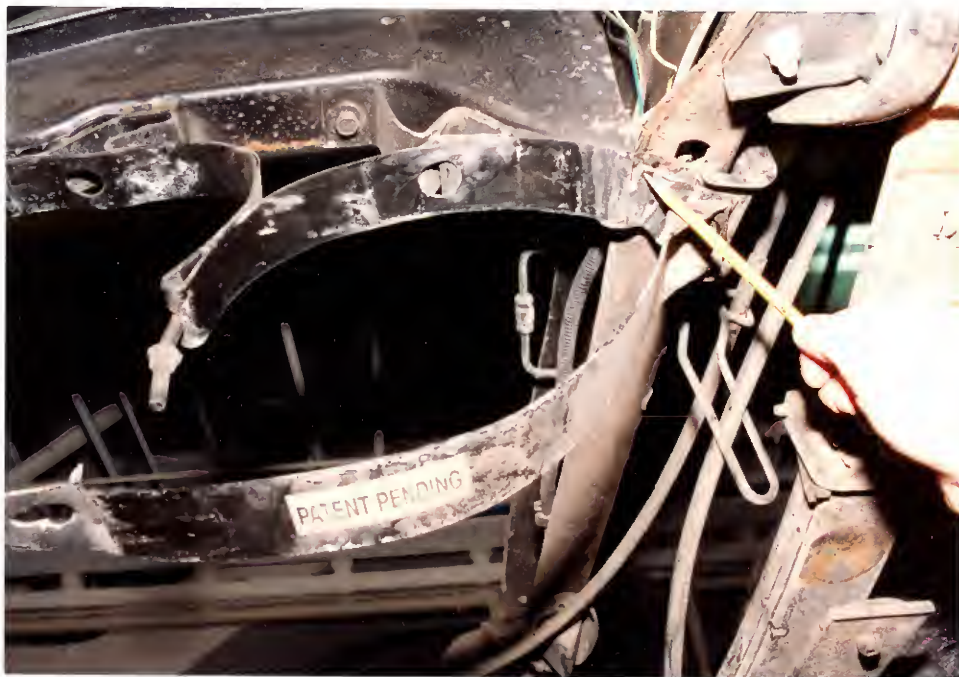
30. Close-up view of the rear tank strap for the failed CNG highlighting a tear in the strap adjacent to the bottom flange of the left frame rail

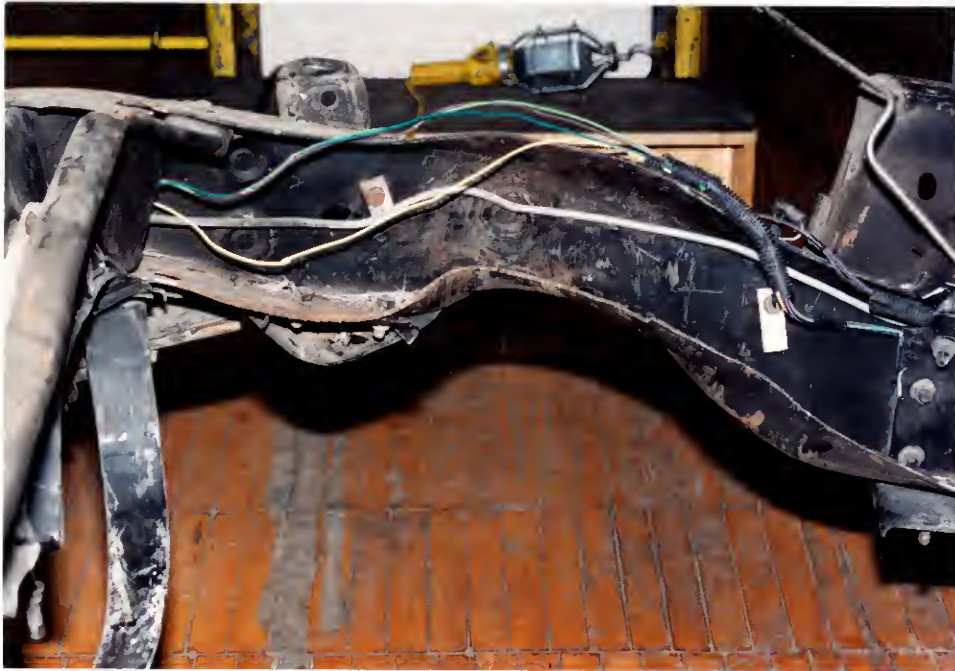
The left frame rail adjacent to the site of the CNG cylinder rupture was displaced outward and upward. Additionally, the lower frame rail edge in this area [approximately 36.8 cm (14.5") in length] rotated upward against the inside of the frame rail. This upward folded damage pattern was located 195.6 cm (77.0") forward of the rear left frame rail end. The total length of frame deformation was 93.7 cm (36.9") which began approximately 182.9 cm (72.0") forward of the left rear frame rail end and extended forward to 276.6 cm (108.9") from the rear frame rail end. The rear cylinder retaining strap of the left cylinder was located 171.2 cm (67.4") forward of the left rear frame rail end and the front strap was positioned 243.21 cm (95.75") forward of the of the same reference point. Within this area, the left spring shackle was attached by a shackle bolt to the outboard vertical side surface of the frame rail which was located 184.79 (72.75") forward of the left rear frame rail end.

33. Close-up view of the left frame rail adjacent to the site of the CNG tank failure

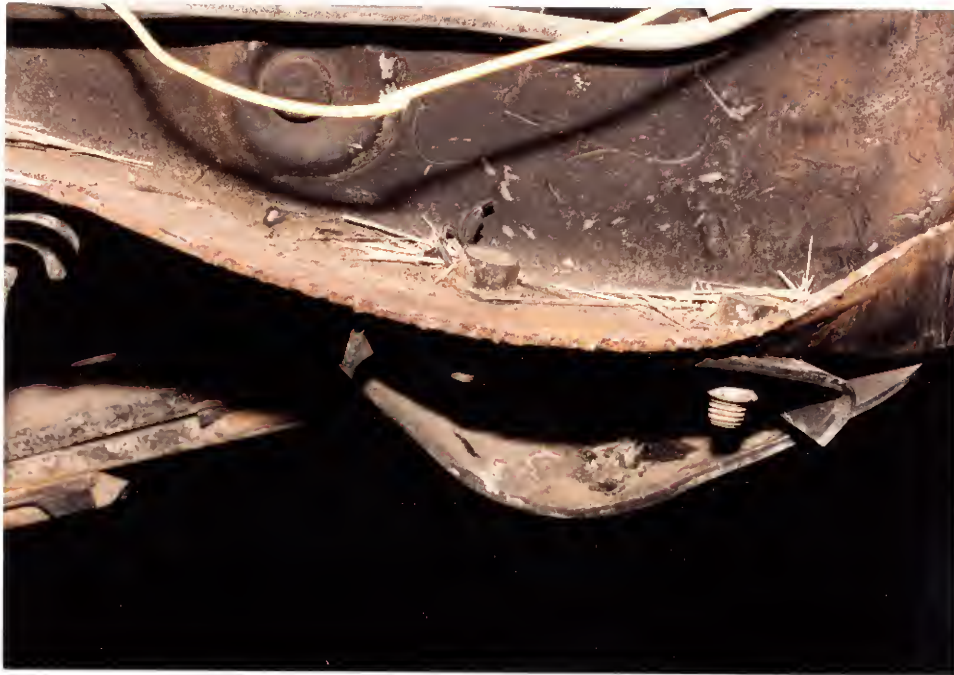
35. Close-up view of the lower flange of the left frame rail in the area adjacent to the CNG tank failure and just forward of the left spring shackle bolt highlighting conversion alteration by retrofit operations

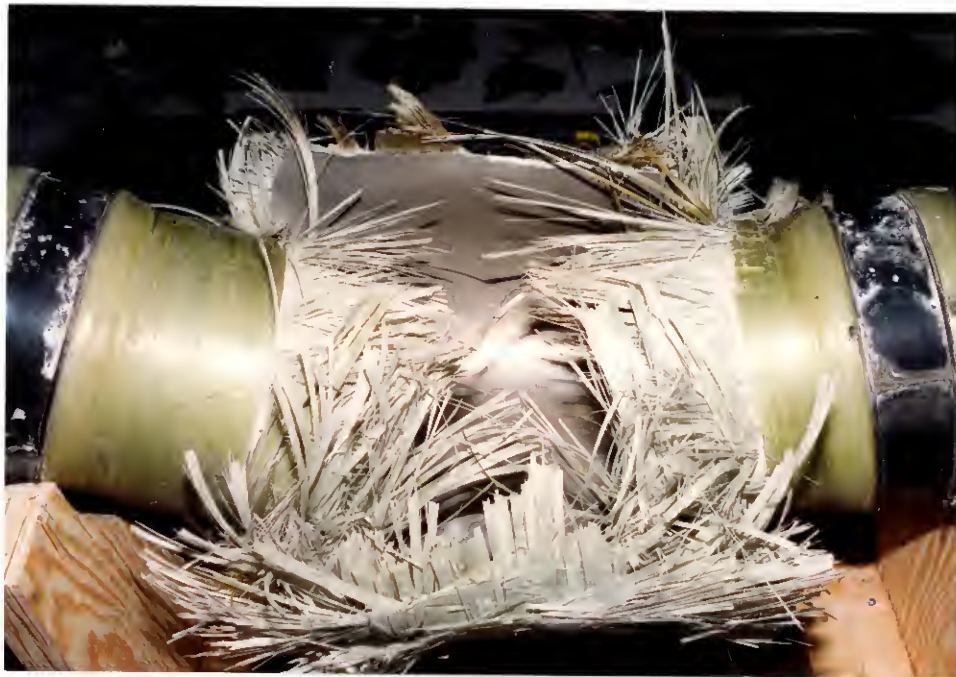
The fiberglass wrap in the area of the rupture appeared to have both a well defined blunt edge fracture pattern and an irregular pattern of shredded fiberglass strands. The blunt edge pattern appeared to be located over the site of the longitudinal aluminum liner rupture line. The shredded pattern appeared to be oriented in a 90° opposed direction along the circumferential rupture line (refer to photographs #39, #40 on page B-21).

39. Close-up view of the failed tank damage with the bottom left side of the tank along the bottom of the photograph and forward end of the tank along the right side of the photograph

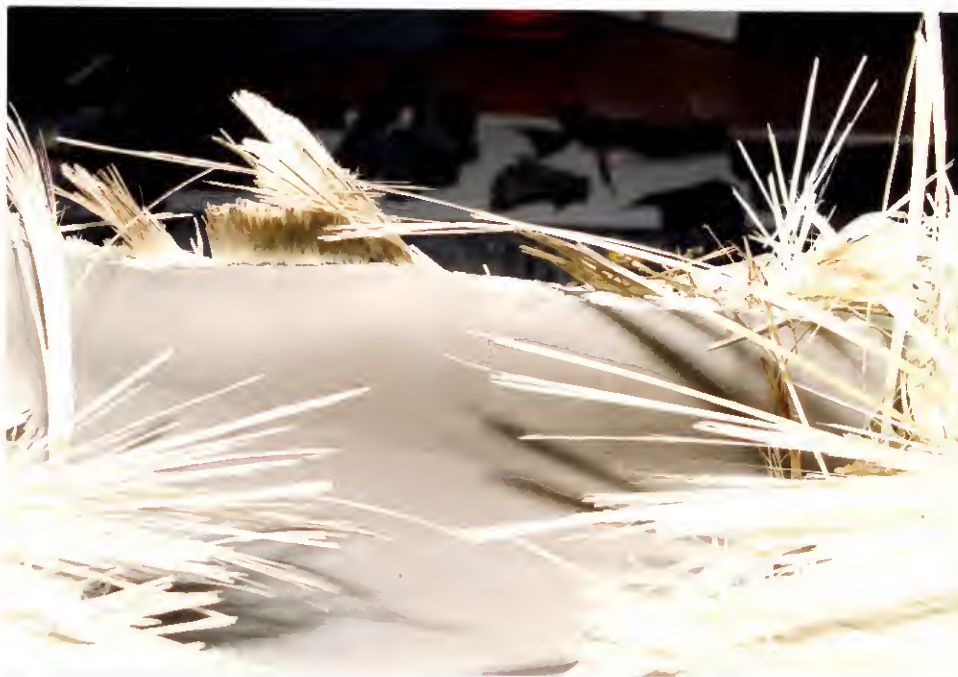
The left flap of the aluminum liner appeared to contact the vehicle's left frame rail during the fracture sequence resulting in a 5.1 cm (2.0") outward and 6.4 cm (2.5") upward displacement of the frame rail. The aluminum liner flap was observed during inspection to be irregularly shaped with at least two fragments separated from the cylinder (photographs #48-#51 on pages B-25-B-27 illustrate one of these fragments). The right flap exhibited a more symmetrical rupture pattern with a relatively straight edge configuration along the longitudinal edge. However, this edge appeared to be bevelled in opposite directions with the forward half of the flap bevelled inward and the rearward portion bevelled outward as shown in photograph #40 on page B-21.

40. Close-up view of the failed tank edge looking at the right side of the tank with the forward end toward the right side of the photograph

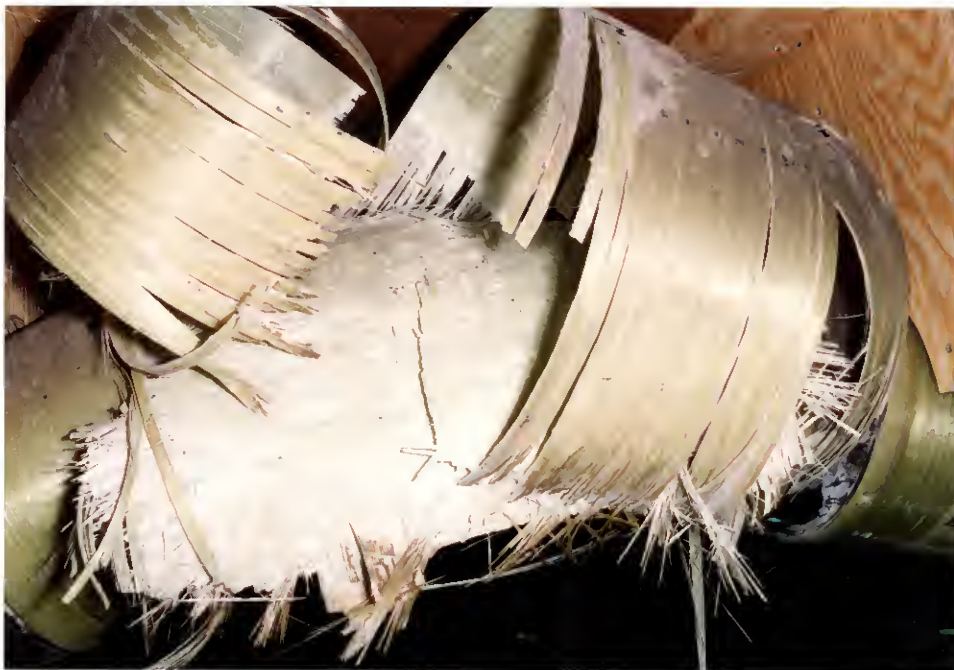
41. View of the top right side of the tank showing the fracture of the composite wrap with the forward end of the tank toward the left side of the photograph

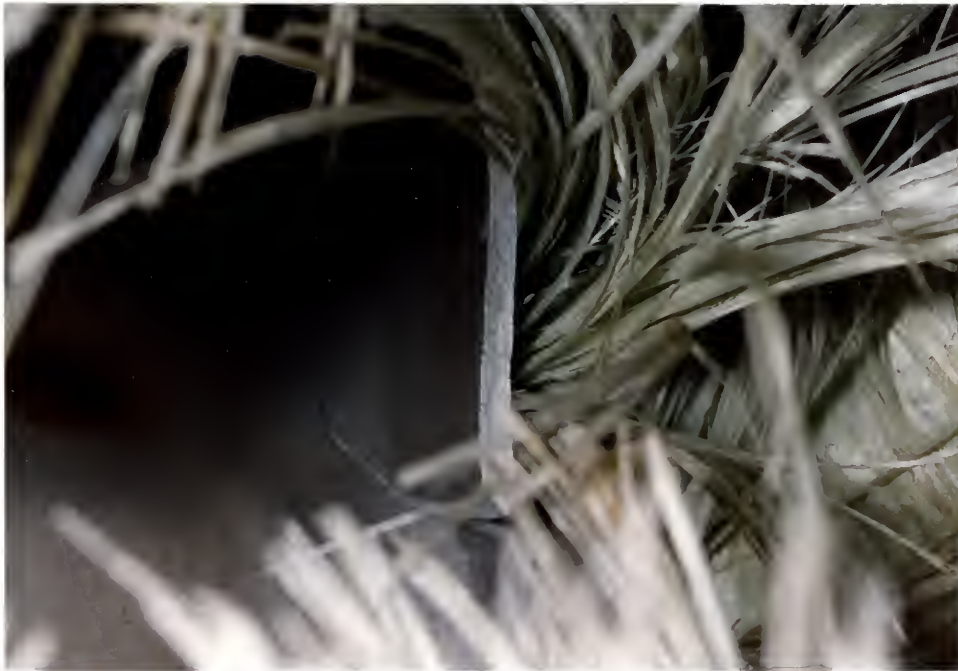
43. Close-up view of the aluminum tank along a fracture line

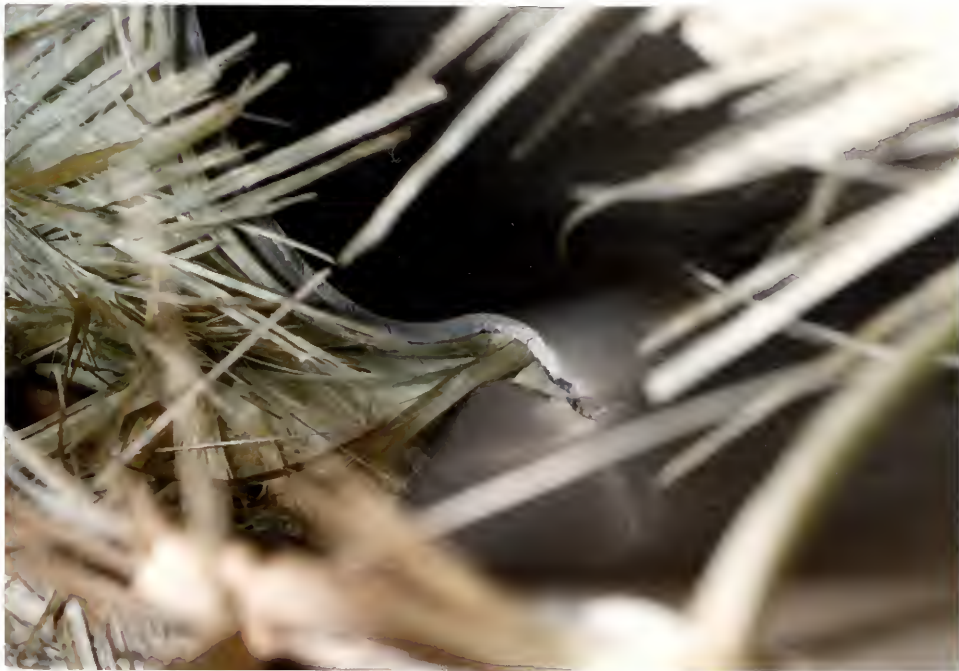
44. Close-up view of a fracture line in the aluminum tank along the bottom left side

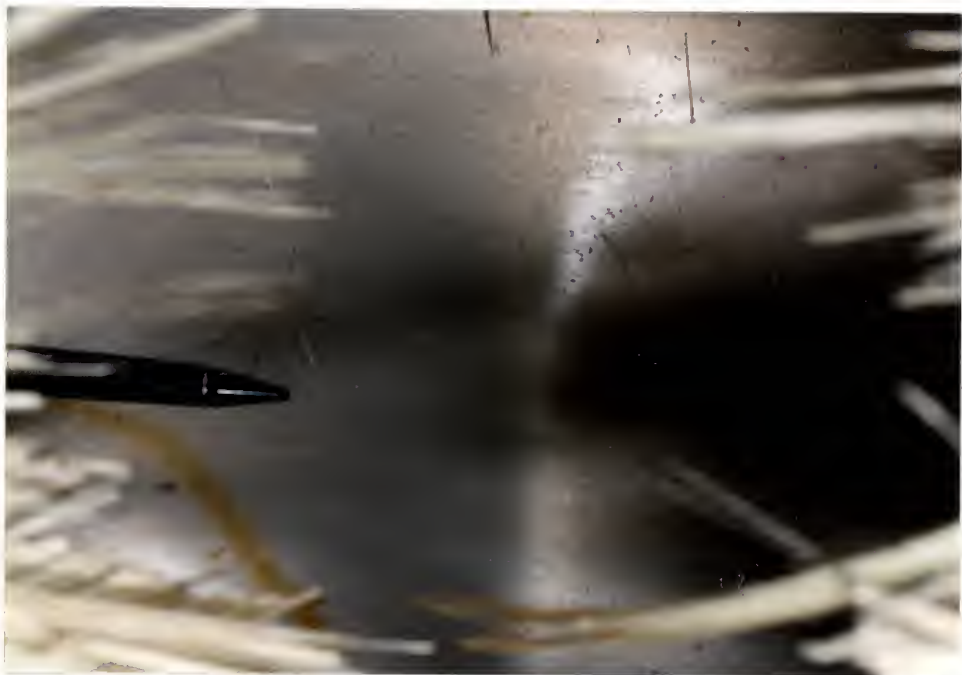
46. Overhead view of the inside of the failed CNG tank highlighting an inward displacement (kink) of the aluminum tank surface with the forward end of the tank toward the left side of the photograph

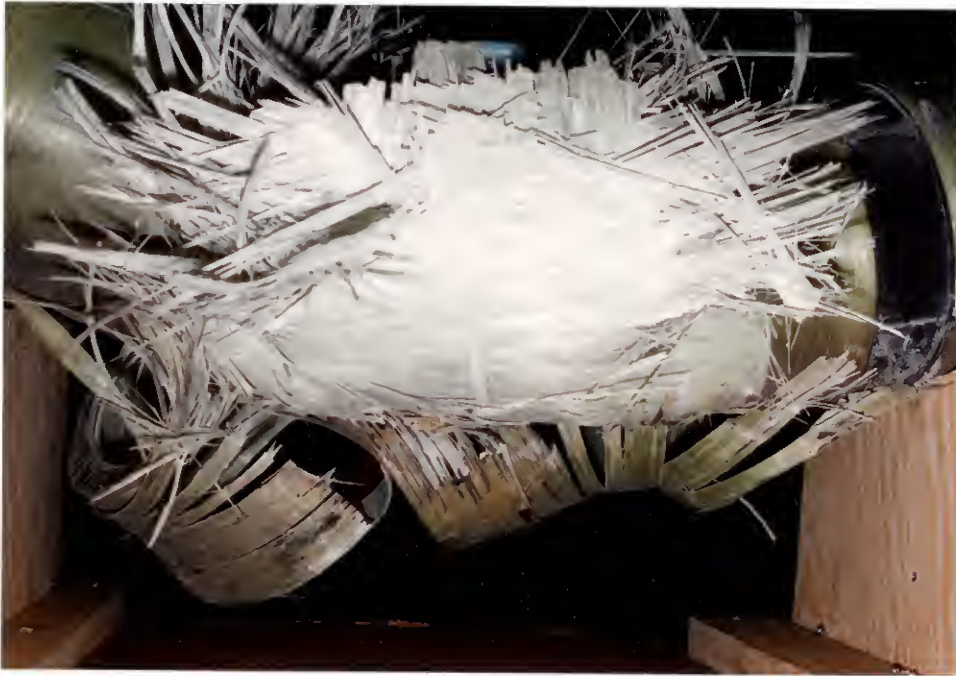
47. View of the top left surface of the fractured composite wrap looking toward the forward end of the tank along the right side of the photograph
